COLUMBIA

ACCIDENT INVESTIGATION BOARD

REPORT VOLUME I
AUGUST 2003

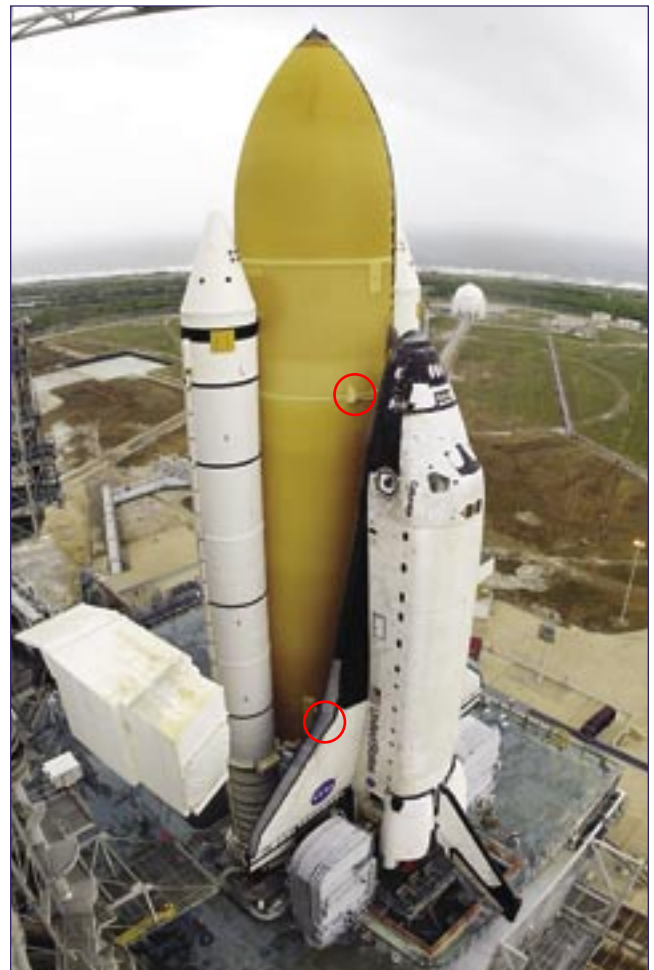
Figure 3.1-1. Columbia sitting at Launch Complex 39-A. The upper circle shows the left bipod (-Y) ramp on the forward attach point, while the lower circle is around RCC panel 8-left.

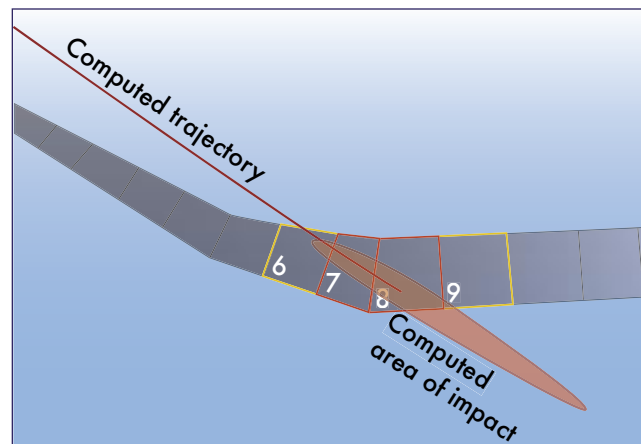
Figure 3.4-3: The best estimate of the site of impact by the center of the foam.

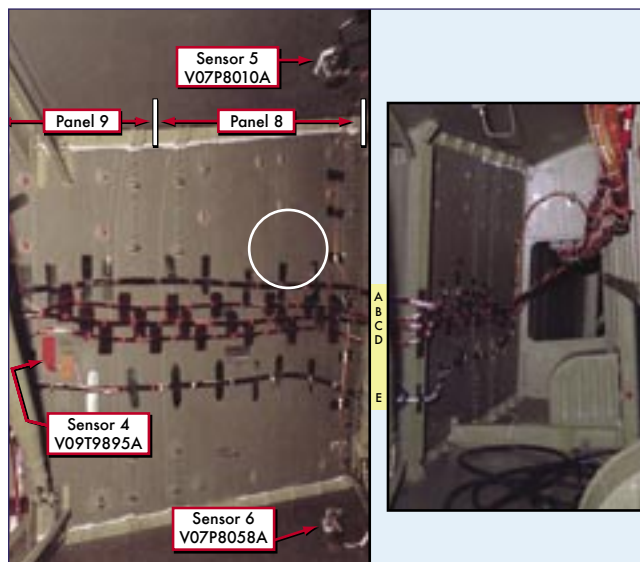
Figure 3.6-8. The left photo above shows the wiring runs on the backside of the wing leading edge behind RCC panel 8 – the circle marks the most likely area where the burn through of the wing leading edge spar initially occurred at EI+487 seconds. The right photo shows the wire bundles as they continue forward behind RCC panels 7 and 6. The major cable bundles in the upper right of the right photo carried the majority of the sensor data inside the wing. As these bundles were burned, controllers on the ground began seeing off-nominal sensor indications.

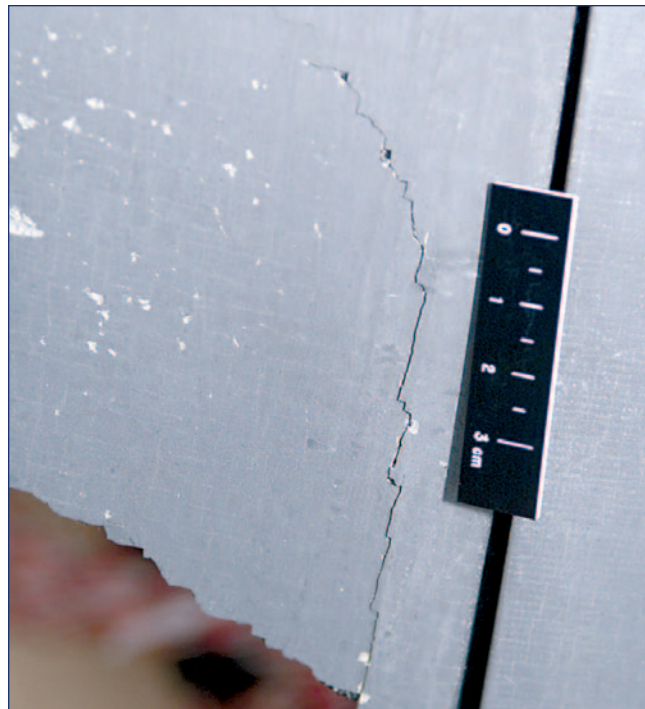
Figure 3.8-10. Numerous cracks were also noted in RCC Panel 8.

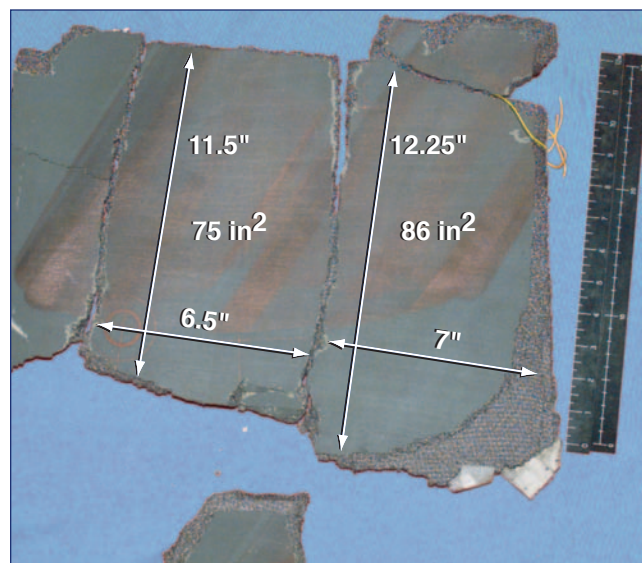
Figure 3.8-11. Three large pieces of debris from the panel face sheet were lodged within the hollow area behind the RCC panel.

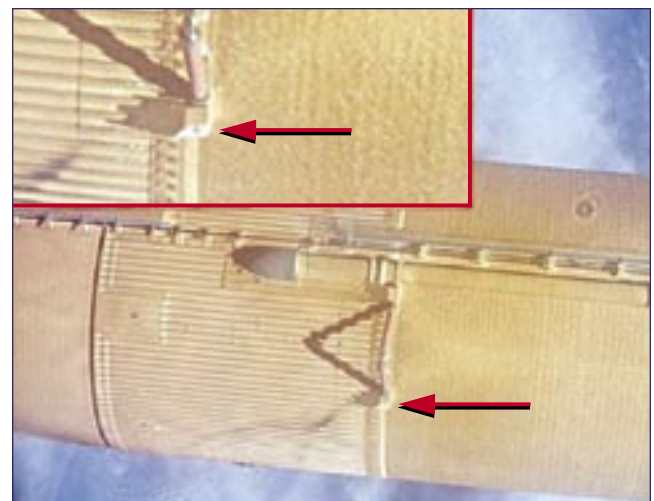
Figure 6.1-3. Only three months before the final launch of Columbia, the bipod ramp foam had come off during STS-112.
