COLUMBIA

ACCIDENT INVESTIGATION BOARD

REPORT VOLUME I
AUGUST 2003

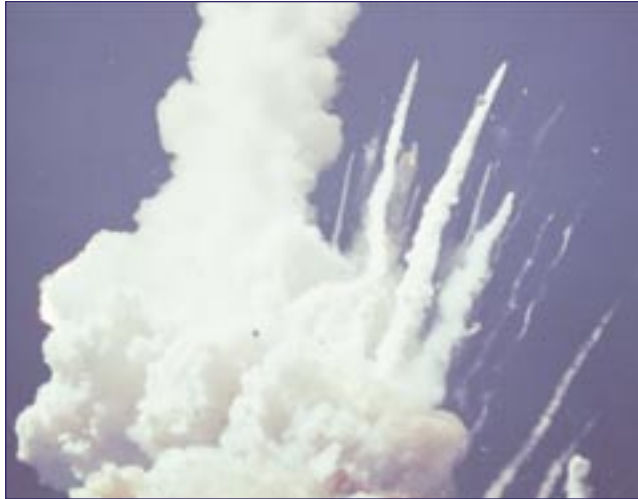
To investigate, President Reagan appointed the 13-member Presidential Commission on the Space Shuttle Challenger Accident, which soon became known as the Rogers Commission, after its chairman, former Secretary of State William P. Rogers.¹⁸ Early in its investigation, the Commission identified the mechanical cause of the accident to be the failure of the joint of one of the Solid Rocket Boosters. The Commission found that the design was not well understood by the engineers that operated it and that it had not been adequately tested.

Figure 1.5-1. the Space Shuttle Challenger was lost during ascent on January 28, 1986, when an O-ring and seal in the left Solid Rocket Booster failed.

The Rogers Commission report, issued on June 6, 1986, recommended a redesign and recertification of the Solid Rocket Motor joint and seal and urged that an independent body oversee its qualification and testing. The report concluded that the drive to declare the Shuttle operational had put enormous pressures on the system and stretched its resources to the limit. Faulting NASA safety practices, the Commission also called for the creation of an independent NASA Office of Safety, Reliability, and Quality Assurance, reporting directly to the NASA Administrator, as well as structural changes in program management.²⁰ (The Rogers Commission findings and recommendations are discussed in more detail in Chapter 5.) It would take NASA 32 months before the next Space Shuttle mission was launched. During this time, NASA initiated a series of longer-term vehicle upgrades, began the construction of the Orbiter *Endeavour* to replace *Challenger*, made significant organizational changes, and revised the Shuttle manifest to reflect a more realistic flight rate.

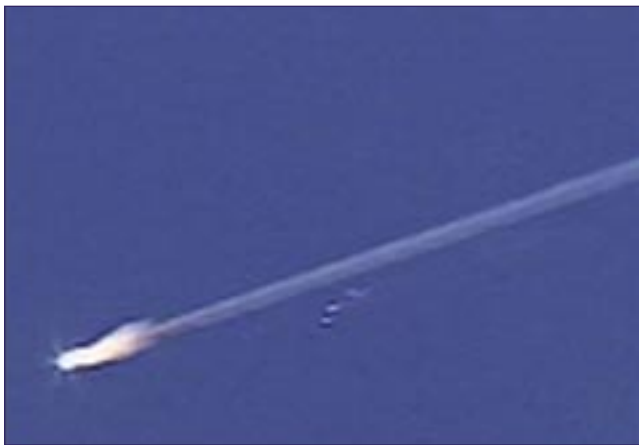
The Orbiter has a large glowing field surrounding it in this view taken from Mesquite, Texas, looking south.

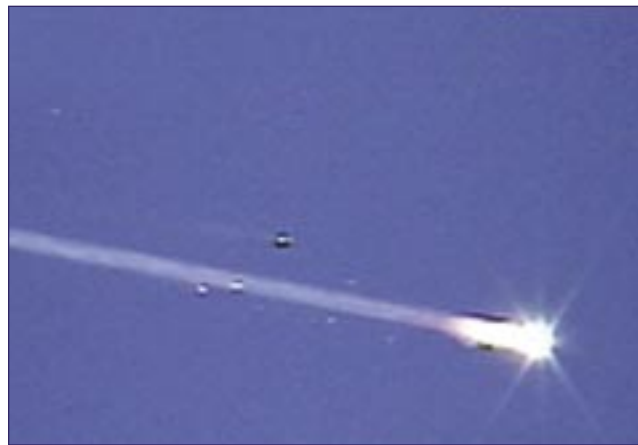
Taken at the same time as the photo at left, but from Hewitt, Texas, looking north.

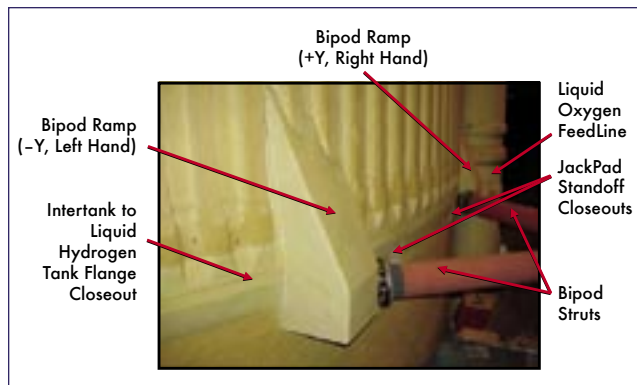
Figure 3.2-2. The exterior of the left bipod attachment area showing the foam ramp that came off during the ascent of STS-107.

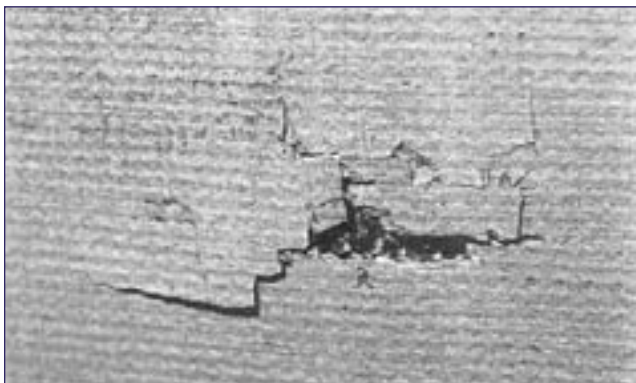
RCC components have been struck by objects throughout their operational life, but none of these components has been completely penetrated. A sampling of 21 post-flight reports noted 43 hypervelocity impacts, the largest being 0.2 inch. The most significant low-velocity impact was to *Atlantis*' panel 10-right during STS-45 in March and April 1992. The damaged area was 1.9 inches by 1.6 inches on the exterior surface and 0.5 inches by 0.1 inches in the interior surface. The substrate was exposed and oxidized, and the panel was scrapped. Analysis concluded that the damage was caused by a strike by a man-made object, possibly during ascent. Figures 3.3-2 and 3.3-3 show the damage to the outer and inner surfaces, respectively.

Figure 3.3-3. Damage on the inner surface of RCC panel 10-right from *Atlantis* after STS-45.

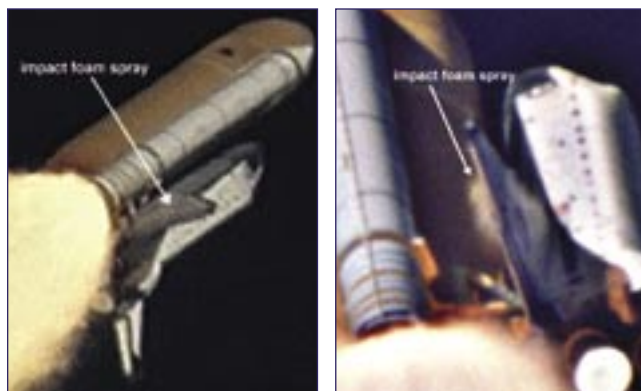
Figure 3.4-1 (color enhanced and "de-blurred" by Lockheed Martin Gaithersburg) and Figure 3.4-2 (processed by the National Imagery and Mapping Agency) are samples of the type of visual data used to establish the time of the impact (81.9 seconds), the altitude at which it occurred (65,860 feet), and the object's relative velocity at impact (about 545 mph relative to the Orbiter).

A 35-mm film camera, E212, which recorded the foam strike from 17 miles away, and video camera E208, which recorded it from 26 miles away, provided the best of the available evidence. Analysis of this visual evidence (see Figures 3.4-1 and 3.4-2) along with computer-aided design analysis, refined the potential impact area to less than 20 square feet in RCC panels 6 through 9 (see Figure 3.4-3), including a portion of the corresponding carrier panels and adjacent tiles. The investigation image analysis team found no conclusive visual evidence of post-impact debris flowing over the top of the wing.

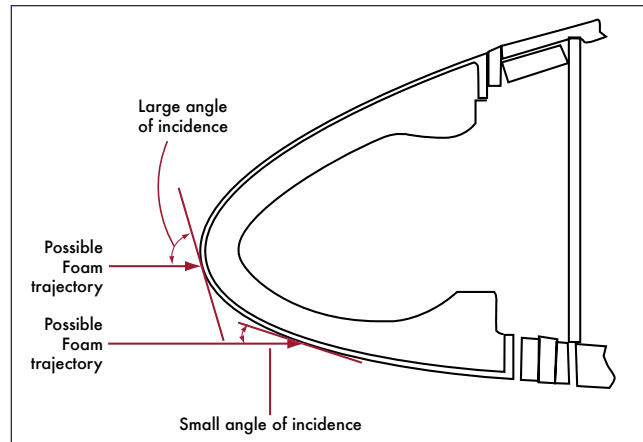
Image analysis determined that the foam was moving almost parallel to the Orbiter's fuselage at impact, with about a five-degree angle upward toward the bottom of the wing and slight motion in the outboard direction. If the foam had hit the tiles adjacent to the leading edge, the angle of incidence would have been about five degrees (the angle of incidence is the angle between the relative velocity of the projectile and the plane of the impacted surface). Because the wing leading edge curves, the angle of incidence increases as the point of impact approaches the apex of an RCC panel. Image and transport analyses estimated that for impact on RCC panel 8, the angle of incidence was between 10 and 20 degrees (see Figure 3.4-4).⁹ Because the total force delivered by the impact depends on the angle of incidence, a foam strike near the apex of an RCC panel could have delivered about twice the force as an impact close to the base of the panel.

Figure 3.4-4. This drawing shows the curve of the wing leading edge and illustrates the difference the angle of incidence has on the effect of the foam strike.

The precise impact location of the foam determined the impact angle because the debris was moving almost parallel to the Orbiter's fuselage at impact. Tile areas would have been hit at very small angles (approximately five degrees), but the curvature of the leading edge created angles closer to 20 degrees (see Figure 3.4-4).

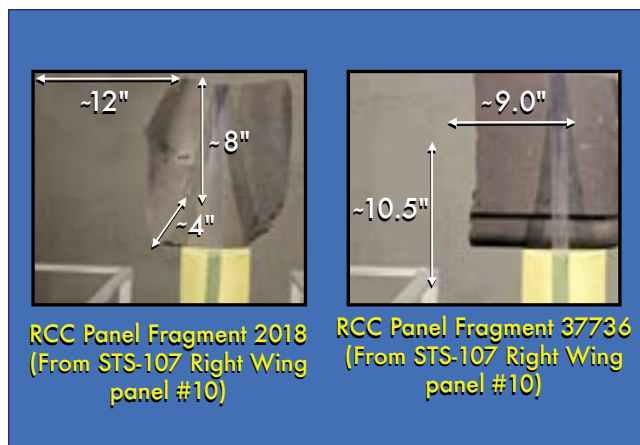
Figure 3.5-1. These representative RCC acreage pieces matched the radar cross-section of the Flight Day 2 object.

In the Advanced Compact Range at the Air Force Research Laboratory in Dayton, Ohio, analysts tested 31 materials from the Orbiter's exterior and payload bay. Additional supercomputer radar cross-section predictions were made for Reinforced Carbon-Carbon T-seals. After exhaustive radar cross-section analysis and testing, coupled with ballistic analysis of the object's orbital decay, only a fragment of RCC panel would match the UHF radar cross-section and ballistic coefficients observed by the Space Surveillance network. Such an RCC panel fragment must be approximately 140 square inches or greater in area to meet the observed radar cross-section characteristics. Figure 3.5-1 shows RCC panel fragments from *Columbia*'s right wing that represent those meeting the observed characteristics of object 2003-003B.¹⁰

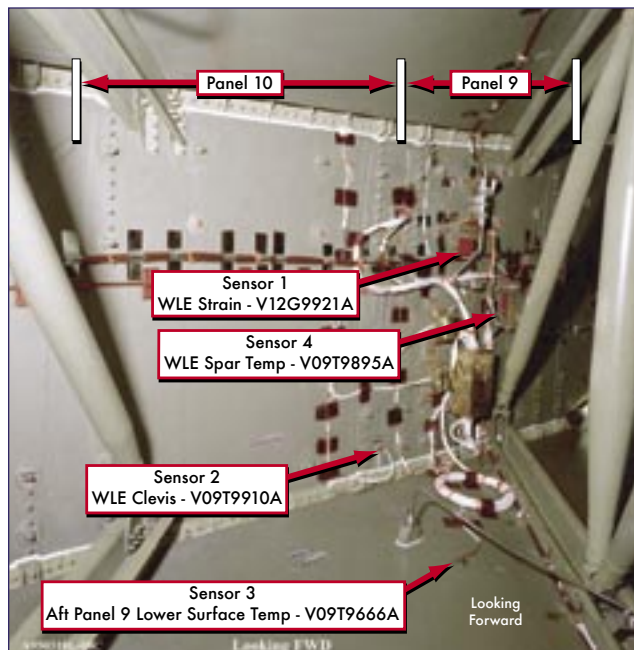
Figure 3.6-2. Location of sensors on the back of the left wing leading edge spar (vertical aluminum structure in picture). Also shown are the round truss tubes and ribs that provided the structural support for the mid-wing in this area.

or outside the wing leading edge spar near Reinforced Carbon-Carbon (RCC) panel 9-left, helped tell the story of what happened on the left wing of the Orbiter early in the re-entry. These four sensors were: strain gauge V12G9921A (Sensor 1), resistance temperature detector V09T9910A on the RCC clevis between panel 9 and 10 (Sensor 2), thermocouple V07T9666A, within a Thermal Protection System tile (Sensor 3), and resistance temperature detector V09T9895A (Sensor 4), located on the back side of the wing leading edge spar behind RCC panels 8 and 9 (see Figure 3.6-2).

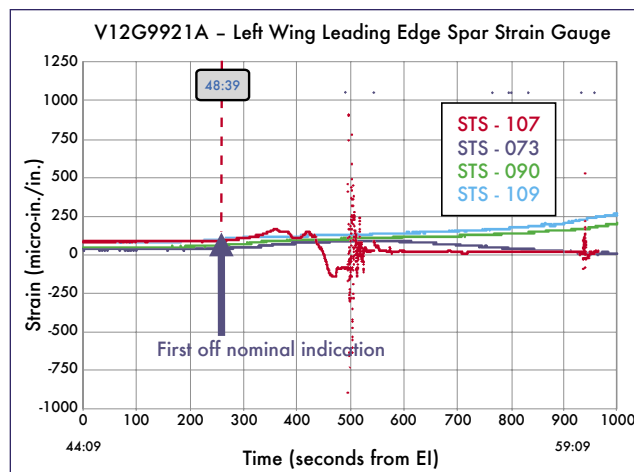
Figure 3.6-3. The strain gauge (Sensor 1) on the back of the left wing leading edge spar was the first sensor to show an anomalous reading. In this chart, and the others that follow, the red line indicates data from STS-107. Data from other *Columbia* re-entries, similar to the STS-107 re-entry profile, are shown in the other colors.

Sensor 1 provided the first anomalous reading (see Figure 3.6-3). From EI+270 to EI+360, the strain is higher than that on previous *Columbia* flights. At EI+450, the strain reverses, and then peaks again in a negative direction at EI+475. The strain then drops slightly, and remains constant and negative until EI+495, when the sensor pattern becomes unreliable, probably due to a propagating soft short, or “burn-through” of the insulation between cable conductors caused by heating or combustion. This strain likely indicates significant damage to the aluminum honeycomb spar. In particular, strain reversals, which are unusual, likely mean there was significant high-temperature damage to the spar during this time.

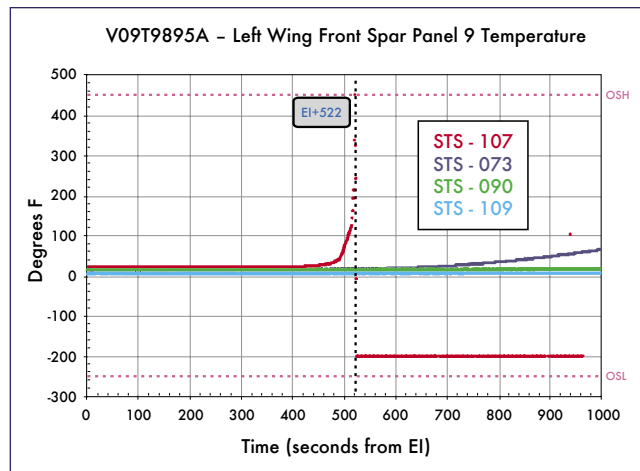
Figure 3.6-7. Sensor 4 also began reading significantly higher than previous flights before it fell off-scale low. The relatively late reaction of this sensor compared to Sensor 2, clearly indicated that superheated air started on the outside of the wing leading edge spar and then moved into the mid-wing after the spar was burned through. Note that immediately before the sensor (or the wire) fails, the temperature is at 450 degrees Fahrenheit and climbing rapidly. It was the only temperature sensor that showed this pattern.

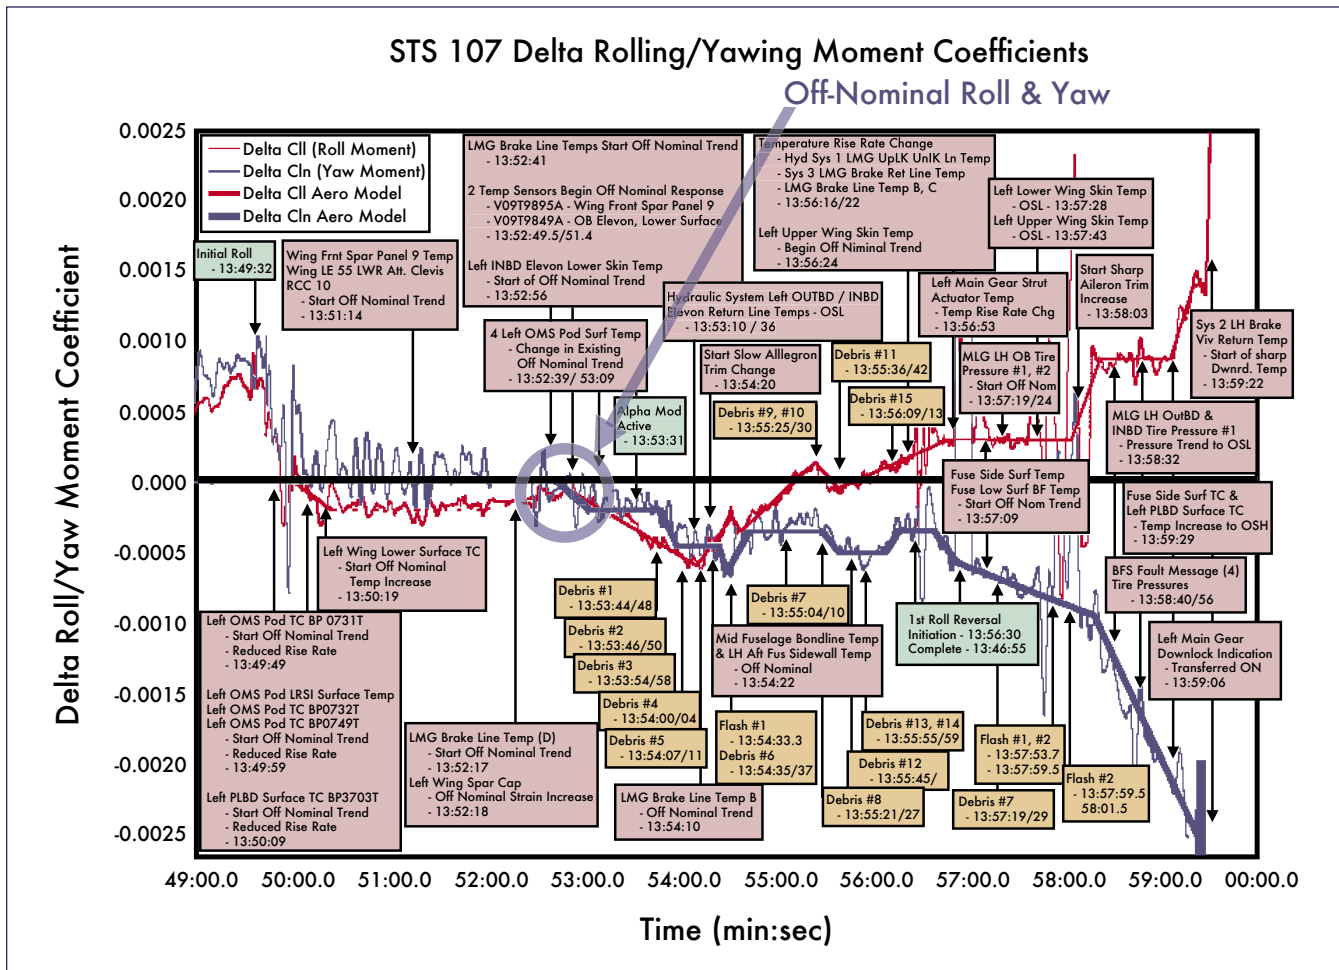
Aerodynamic roll and yaw forces began to differ from those on previous flights at about EI+500 (see Figure 3.6-12). Investigators used flight data to reconstruct the aerodynamic forces acting on the Orbiter. This reconstructed data was then compared to forces seen on other similar flights of *Columbia*

Figure 3.6-12. At approximately EI+500 seconds, the aerodynamic roll and yaw forces began to diverge from those observed on previous flights. The blue line shows the Orbiter's tendency to yaw while the red line shows its tendency to roll. Nominal values would parallel the solid black line. Above the black line, the direction of the force is to the right, while below the black line, the force is to the left.

and to the forces predicted for STS-107. In the early phase of flight, these abnormal aerodynamic forces indicated that *Columbia's* flight control system was reacting to a change in the external shape of the wing, which was caused by progressive RCC damage that caused a continuing decrease in lift and a continuing increase in drag on the left wing.

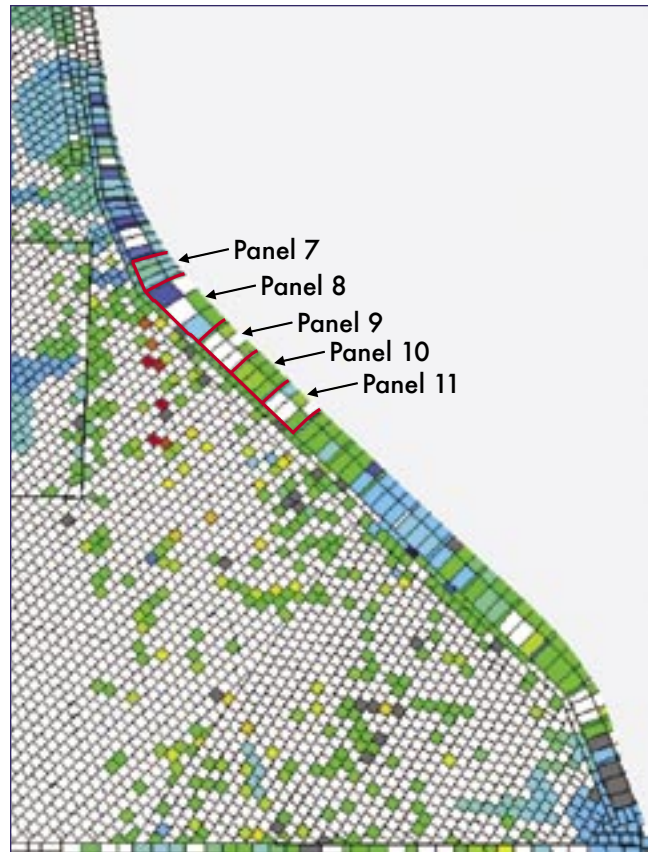
Figure 3.7-6. The tiles recovered farthest west all came from the area immediately behind left wing RCC panels 8 and 9. In the figure, each small box represents an individual tile on the lower surface of the left wing. The more red an individual tile appears, the farther west it was found.

An analysis of where tiles were found on the ground also yielded significant evidence of the breach location. Since most of the tiles are of similar size, weight, and shape, they would all have similar ballistic coefficients and would have behaved similarly after they separated from the Orbiter. By noting where each tile fell and then plotting its location on the Orbiter tile map, a distinctive pattern emerged. The tiles recovered farthest west all came from the area immediately behind the left wing RCC panel 8 and 9 (see Figure 3.7-6), which suggests that these tiles were released earlier than those from other areas of the left wing. While it is not conclusive evidence of a breach in this area, this pattern does suggest unique damage around RCC panels 8 and 9 that was not seen in other areas. Tiles from this area also showed evidence of a brown deposit that was not seen on tiles from any

other part of the Orbiter. Chemical analysis revealed it was an Inconel-based deposit that had come from inside the RCC cavity on the left wing (Inconel is found in wing leading edge attachment fittings). Since the streamlines from tiles with the brown deposit originate near left RCC panels 8 and 9, this brown deposit likely originated as an outflow of superheated air and molten metal from the panel 8 and 9 area.

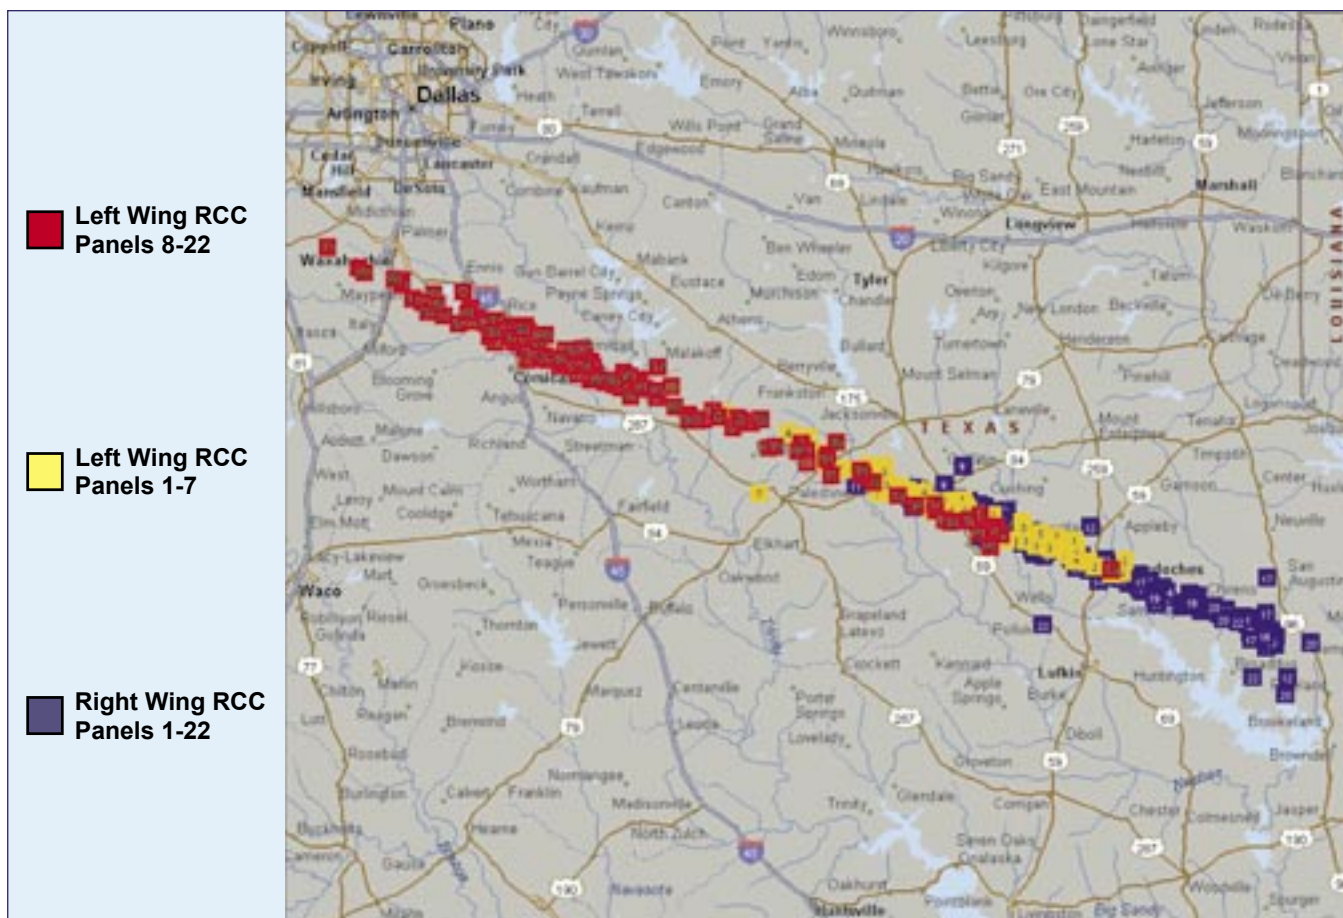
Figure 3.7-5. The location of RCC panel debris from the left and right wings, shown where it was recovered from in East Texas. The debris pattern suggested that the left wing failed before the right wing, most likely near left RCC panels 8 and 9.

found throughout the debris field, which suggested that the left wing likely failed in the vicinity of RCC panel 8. The early loss of the left wing from RCC panel 9 and outboard caused the RCC from that area to be deposited well west of the RCC from the inboard part of the wing. Since panels 1 through 7 were so much farther to the east, investigators concluded that RCC panels 1 through 7 had stayed with the Orbiter longer than had panels 8 through 22.

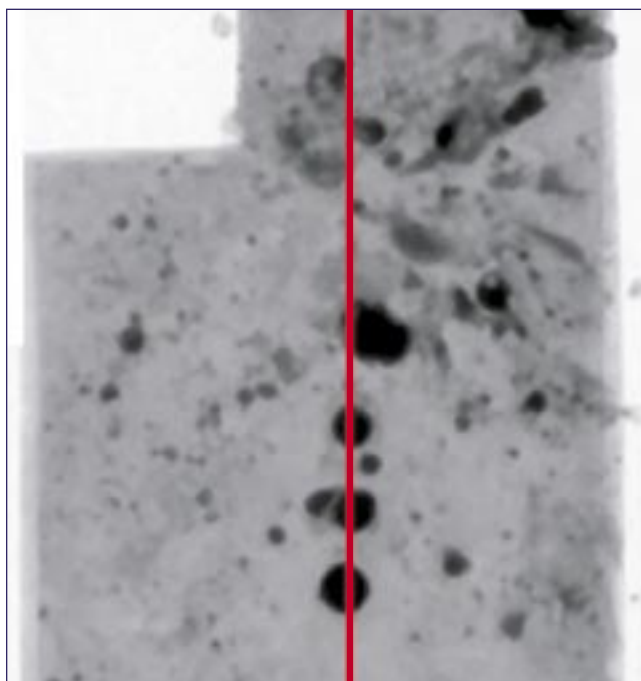
The X-ray analysis of left wing RCC panel 8 (see Figure 3.7-7) showed a bottom-to-top pattern of slag deposits. In some areas, small spheroids of heavy metal were aligned vertically on the recovered pieces, which indicated a superheated airflow from the bottom of the panel toward the top in the area of RCC panel 8-left. These deposits were later determined by chemical analysis to be Inconel 718, probably from the wing leading edge attachment fittings on the spanner beams on RCC panels 8 and 9. Computational fluid dynamics modeling of the flow behind panel 8 indicated that the molten deposits would be laid down in this manner.

Figure 3.7-7. X-ray analysis of RCC panel 8-left showed a bottom-to-top pattern of slag deposits.

The layered deposits on panel 8 were also markedly different from those on all other left- and right-wing panels. There was much more material deposited on RCC panel 8-left. These deposits had a much rougher overall structure, including rivulets of Cerachrome slag deposited directly on the RCC. This indicated that Cerachrome, the insulation that protects the wing leading edge spar, was one of the first materials to succumb to the superheated air entering through the breach in RCC panel 8-left. Because the melting temperature of Cerachrome is greater than 3,200 degrees Fahrenheit, analysis indicated that materials in this area were exposed to extremely

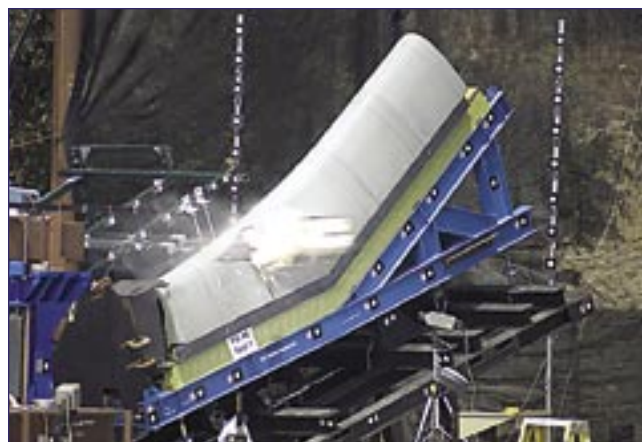
Figure 3.8-5. A typical foam strike leaves impact streaks, and the foam projectile breaks into shards and larger pieces. Here the foam is striking Panel 6 on a fiberglass test article.

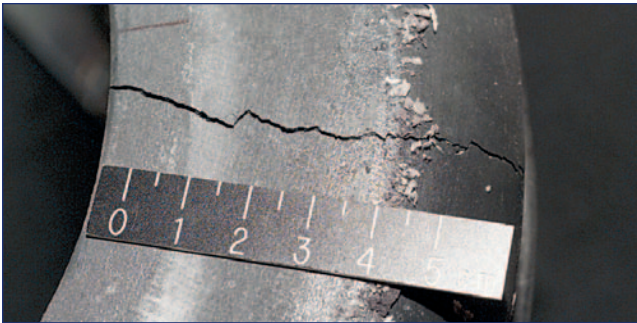
RCC panel 6 was tested first to begin to establish RCC impact response, although by the time of the test, other data had indicated that RCC panel 8-left was the most likely site of the breach. RCC panel 6 was impacted using the same parameters as the test on fiberglass panel 6 and developed a 5.5-inch crack on the outboard end of the panel that extended through the rib (see Figure 3.8-6). There was also a crack through the "web" of the T-seal between panels 6 and 7 (see Figure 3.8-7). As in the fiberglass test, the foam block deflected, or moved, the face of the RCC panel, creating a slit between the panel and the adjacent T-seal, which ripped the projectile and stuffed pieces of foam into the slit (see Figure 3.8-8). The panel rib failed at lower stresses than predicted, and the T-seal failed closer to predictions, but overall, the stress pattern was similar to what was predicted, demonstrating the need to incorporate more complete RCC failure criteria in the computational models.

Without further crack growth, the specific structural damage this test produced would probably not have allowed enough superheated air to penetrate the wing during re-entry to cause serious damage. However, the test did demonstrate that a foam impact representative of the debris strike at 81.9 seconds after launch could damage an RCC panel. Note that

Figure 3.8-6. A 5.5-inch crack on the outboard portion of RCC Panel 6 during testing.

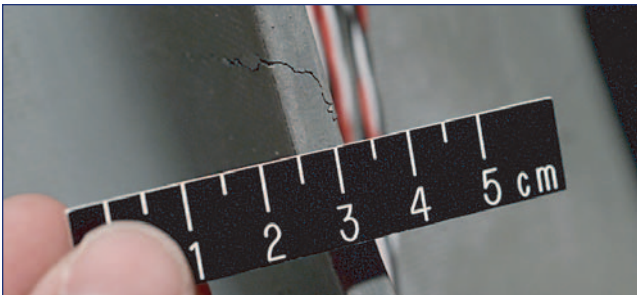
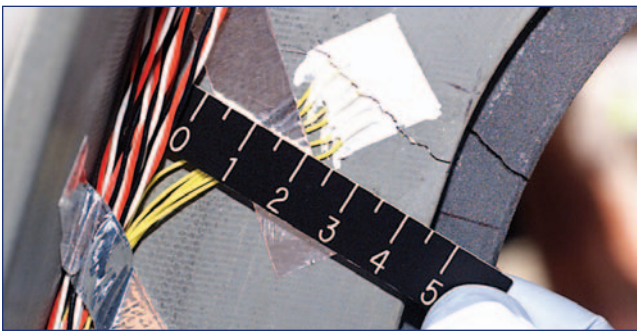
Figure 3.8-7. Two views of the crack in the T-seal between RCC Panels 6 and 7.

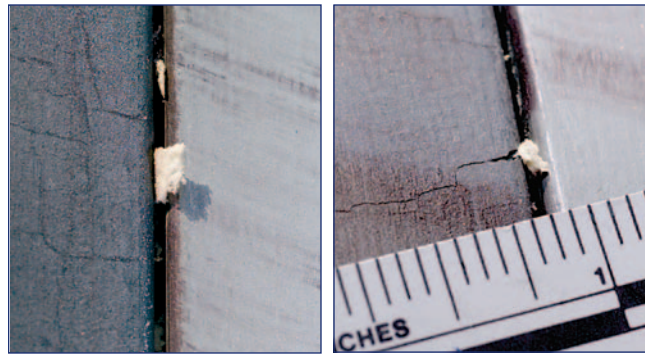
Figure 3.8-8. Two views of foam lodged into the slit during tests.

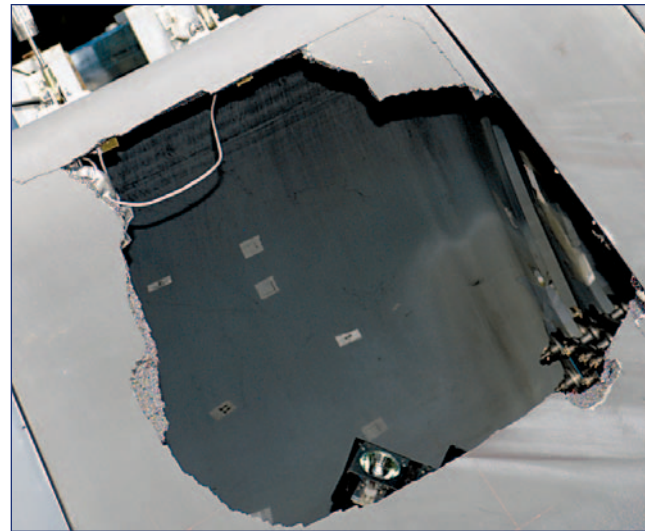
Figure 3.8-9. The large impact hole in Panel 8 from the final test.

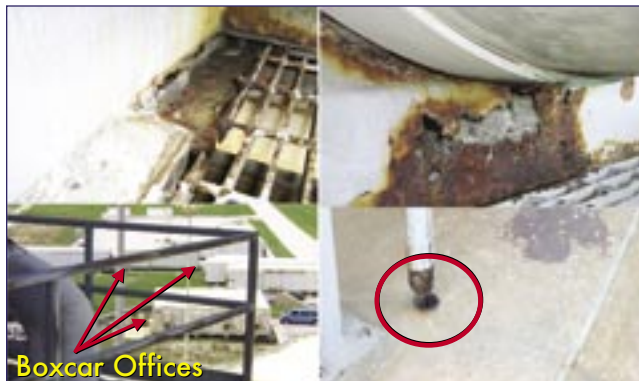
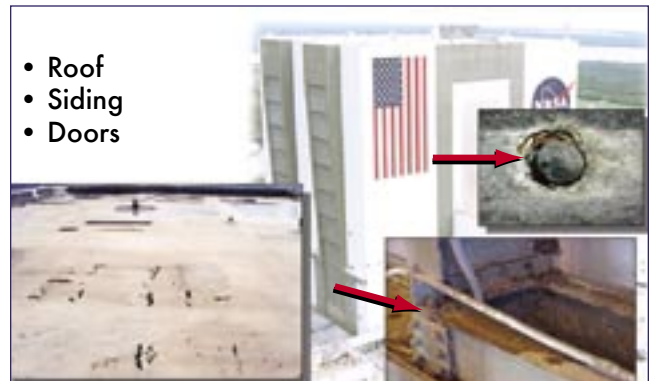
Figure 5.5-5 and 5.5-6. Examples of the seriously deteriorating infrastructure used to support the Space Shuttle Program. At left is Launch Complex 39A, and at right is the Vehicle Assembly building, both at the Kennedy Space Center.

Board investigators have identified deteriorating infrastructure associated with the launch pads, Vehicle Assembly Building, and the crawler transporter. Figures 5.5-5 and 5.5-6 depict some of this deterioration. For example, NASA has installed nets, and even an entire sub-roof, inside the Vehicle Assembly Building to prevent concrete from the building’s ceiling from hitting the Orbiter and Shuttle stack. In addition, the corrosion-control challenge results in zinc primer

on certain launch pad areas being exposed to the elements. When rain falls on these areas, it carries away zinc, runs onto the leading edge of the Orbiter’s wings, and causes pinholes in the Reinforced Carbon-Carbon panels (see Chapter 3).

In Fiscal Year 2002, Congress added \$25 million to NASA’s budget for Vehicle Assembly Building repairs. NASA has reallocated limited funds from the Shuttle budget to pressing infrastructure repairs, and intends to take an integrated look at infrastructure as part of its new Shuttle Service Life Extension Program. Nonetheless, like Space Shuttle upgrades, infrastructure revitalization has been mired by the uncertainty surrounding the Shuttle Program’s lifetime. Considering that the Shuttle will likely be flying for many years to come, NASA, the White House, and Congress alike now face the specter of having to deal with years of infrastructure neglect.

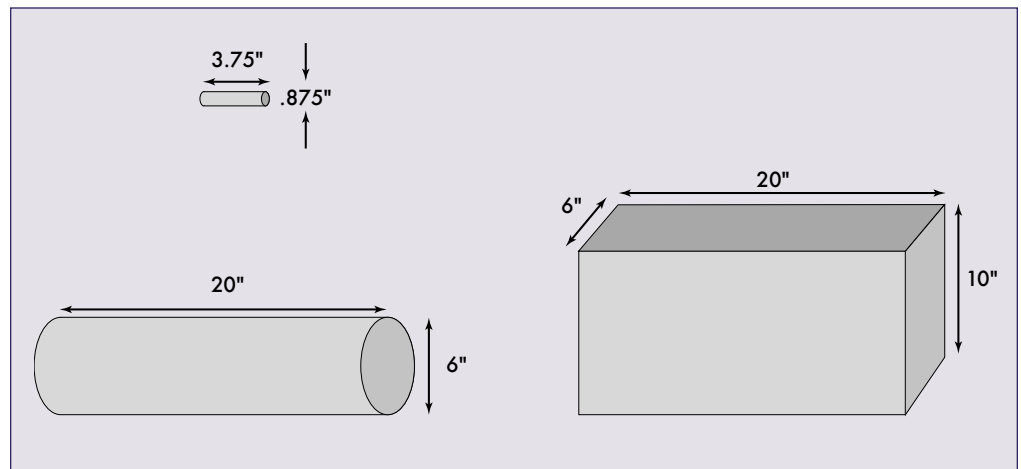
Until STS-107, Crater was normally used only to predict whether small debris, usually ice on the External Tank, would pose a threat to the Orbiter during launch. The use of Crater to assess the damage caused by foam during the launch of STS-107 was the first use of the model while a mission was on orbit. Also of note is that engineers used Crater during STS-107 to analyze a piece of debris that was at maximum 640 times larger in volume than the pieces of debris used to calibrate and validate the Crater model (the Board's best estimate is that it actually was 400 times larger). Therefore, the use of Crater in this new and very different situation compromised NASA's ability to accurately predict debris damage in ways that Debris Assessment Team engineers did not fully comprehend (see Figure 6.3-1).

Figure 6.3-1. The small cylinder at top illustrates the size of debris Crater was intended to analyze. The larger cylinder was used for the STS-107 analysis; the block at right is the estimated size of the foam.

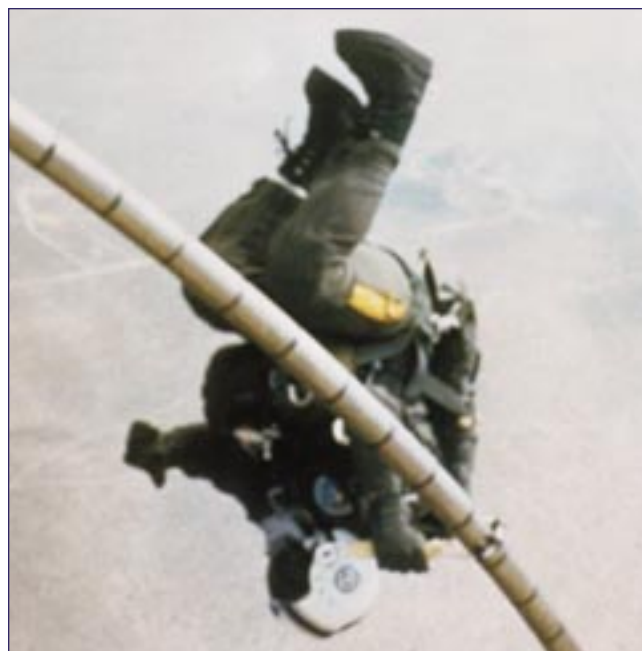
In response to this recommendation, NASA developed the current “pole bailout” system for use during controlled, subsonic gliding flight (see Figure 10.2-1). The system requires crew members to “vent” the cabin at 40,000 feet (to equalize the cabin pressure with the pressure at that altitude), jettison the hatch at approximately 32,000 feet, and then jump out of the vehicle (the pole allows crew members to avoid striking the Orbiter’s wings).

Figure 10.2-1. A demonstration of the pole bailout system. The pole is extending from the side of a C-141 simulating the Orbiter, with a crew member sliding down the pole so that he would fall clear of the Orbiter’s wing during an actual bailout.

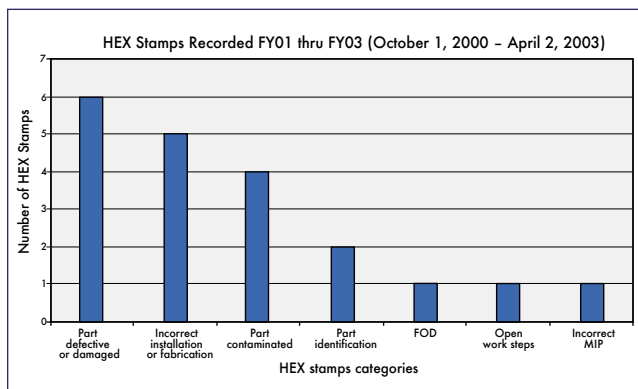
Of the 141,127 inspections subject to rejection from October 2000 through March 2003, only 20 rejections, or "hexes," were recorded, resulting in a statistically improbable discrepancy rate of .014 percent (see Figure 10.4-4). In interviews, technicians and inspectors alike confirmed the dubiousness of this rate. NASA's published rejection rate therefore indicates either inadequate documentation or an underused system. Testimony further revealed incidents of quality assurance inspectors being played against each other to accept work that had originally been refused.

Figure 10.4-4. Rejection, or "Hex" stamps issued from October 2000 through April 2003.
